Inspection Report

Minerals Regulatory Program

Mine Name: Deremo-Peterson

Permit number: M/037/025

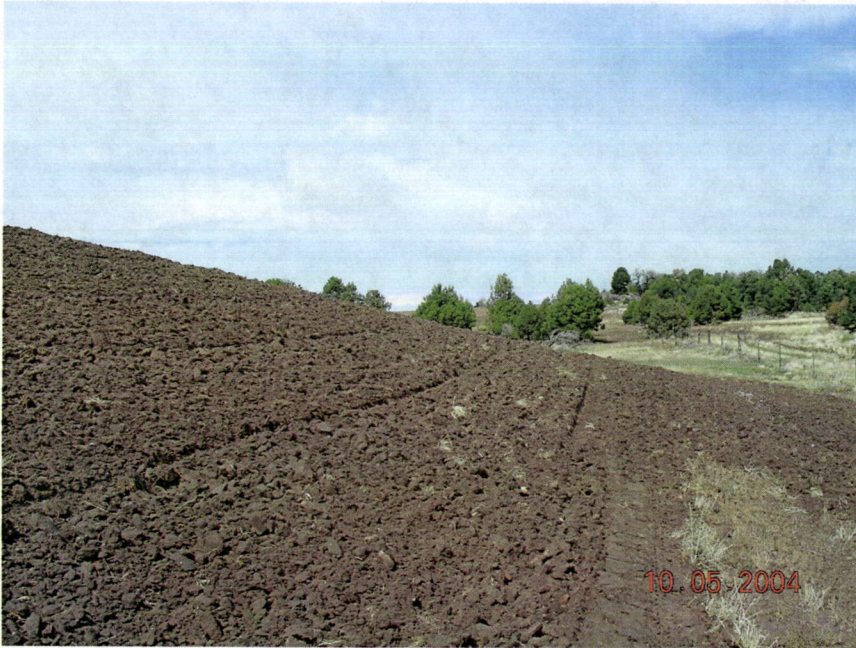
Portions of the waste pile had been harrowed (Photo 1), possibly to get the surface ready for seeding or to reduce the number of weeds. I have some concerns about the lack of surface roughness, but I think the slope is gentle enough that this seeding can work if there is adequate moisture.

Photo 1. The harrowed slope of the waste pile.

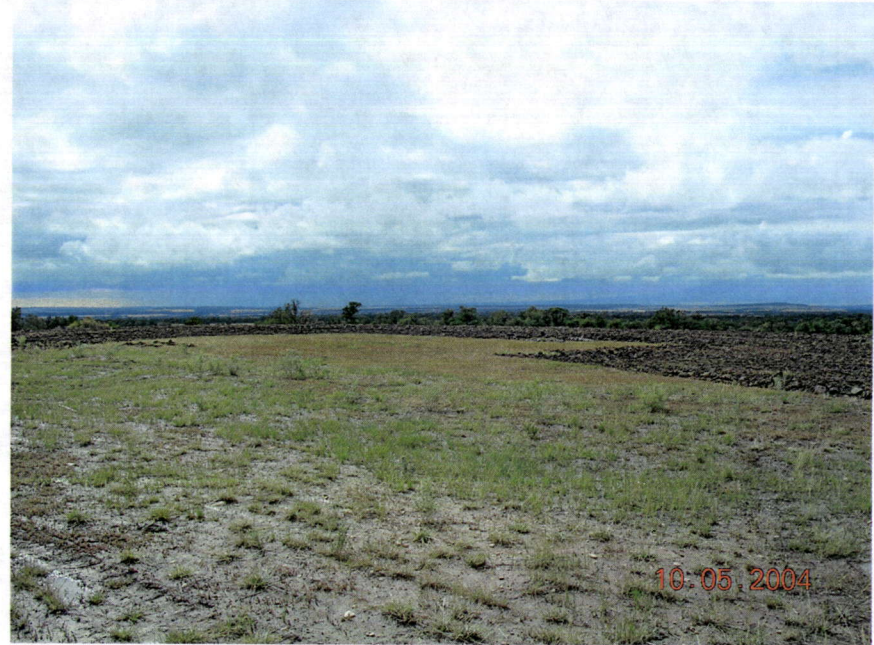
Photo 2. The top of the waste pile. The area in the foreground was not harrowed because it has desirable grasses, but some of the other areas were not harrowed because the equipment was getting stuck in the rain-softened ground.

There had been a lot of rain, and the ground was muddy. The operator had planned to seed and fertilize those parts of the waste pile where revegetation has not been successful. The plan was to apply the seed and fertilizer then harrow the area. It was too muddy to use the harrow, so the operator plans to come back in a few days when the ground has dried a bit.
